FTC-TR-71-37

**CATEGORY II AIRFRAME AND
SUBSYSTEMS EVALUATION**

UH-1N

SUBJECT ASD Addendum Report to FTC-TR-71-37, UH-1N Airframe and
Subsystems Evaluation

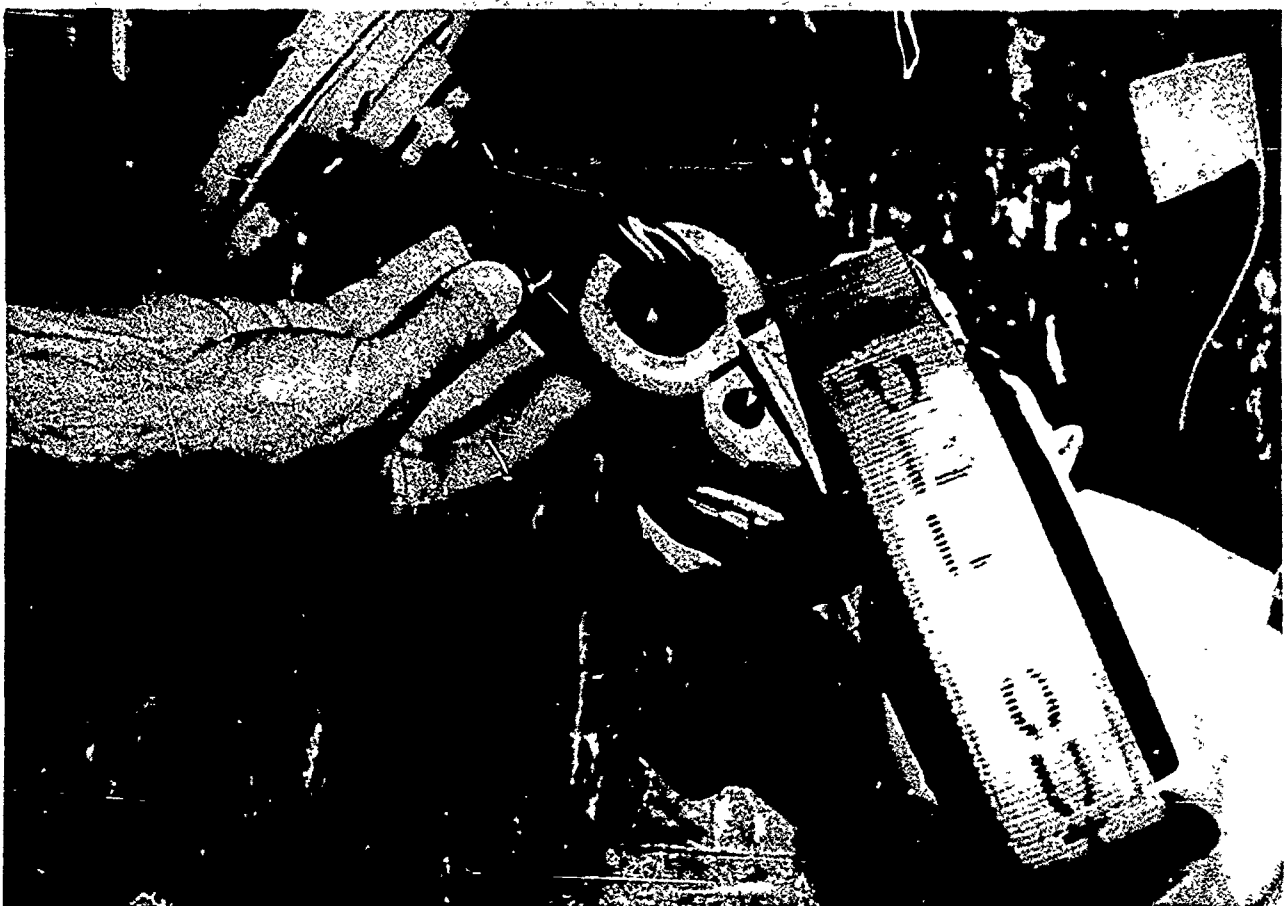
Figure 2 Hoist Hook with Forest Penetrator Attached

The suspension hook on this hoist featured a two-piece assembly intended to retain attached accessories. The main hook closure was spring loaded in the closed direction (figures 2 and 3). A safety clasp was provided to prevent inadvertent opening of the main closure. This clasp was held in place by dimples stamped into its sides. These were not adequate to retain the clasp reliably. With the clasp open, it was found that the forest penetrator could be twisted so as to push the main closure aside, releasing itself from the hook. Such a condition is likely to occur during impact with the ground or tree branches, causing possible loss of the penetrator. A positive locking hook closure should be incorporated to eliminate this possibility. (R 8)

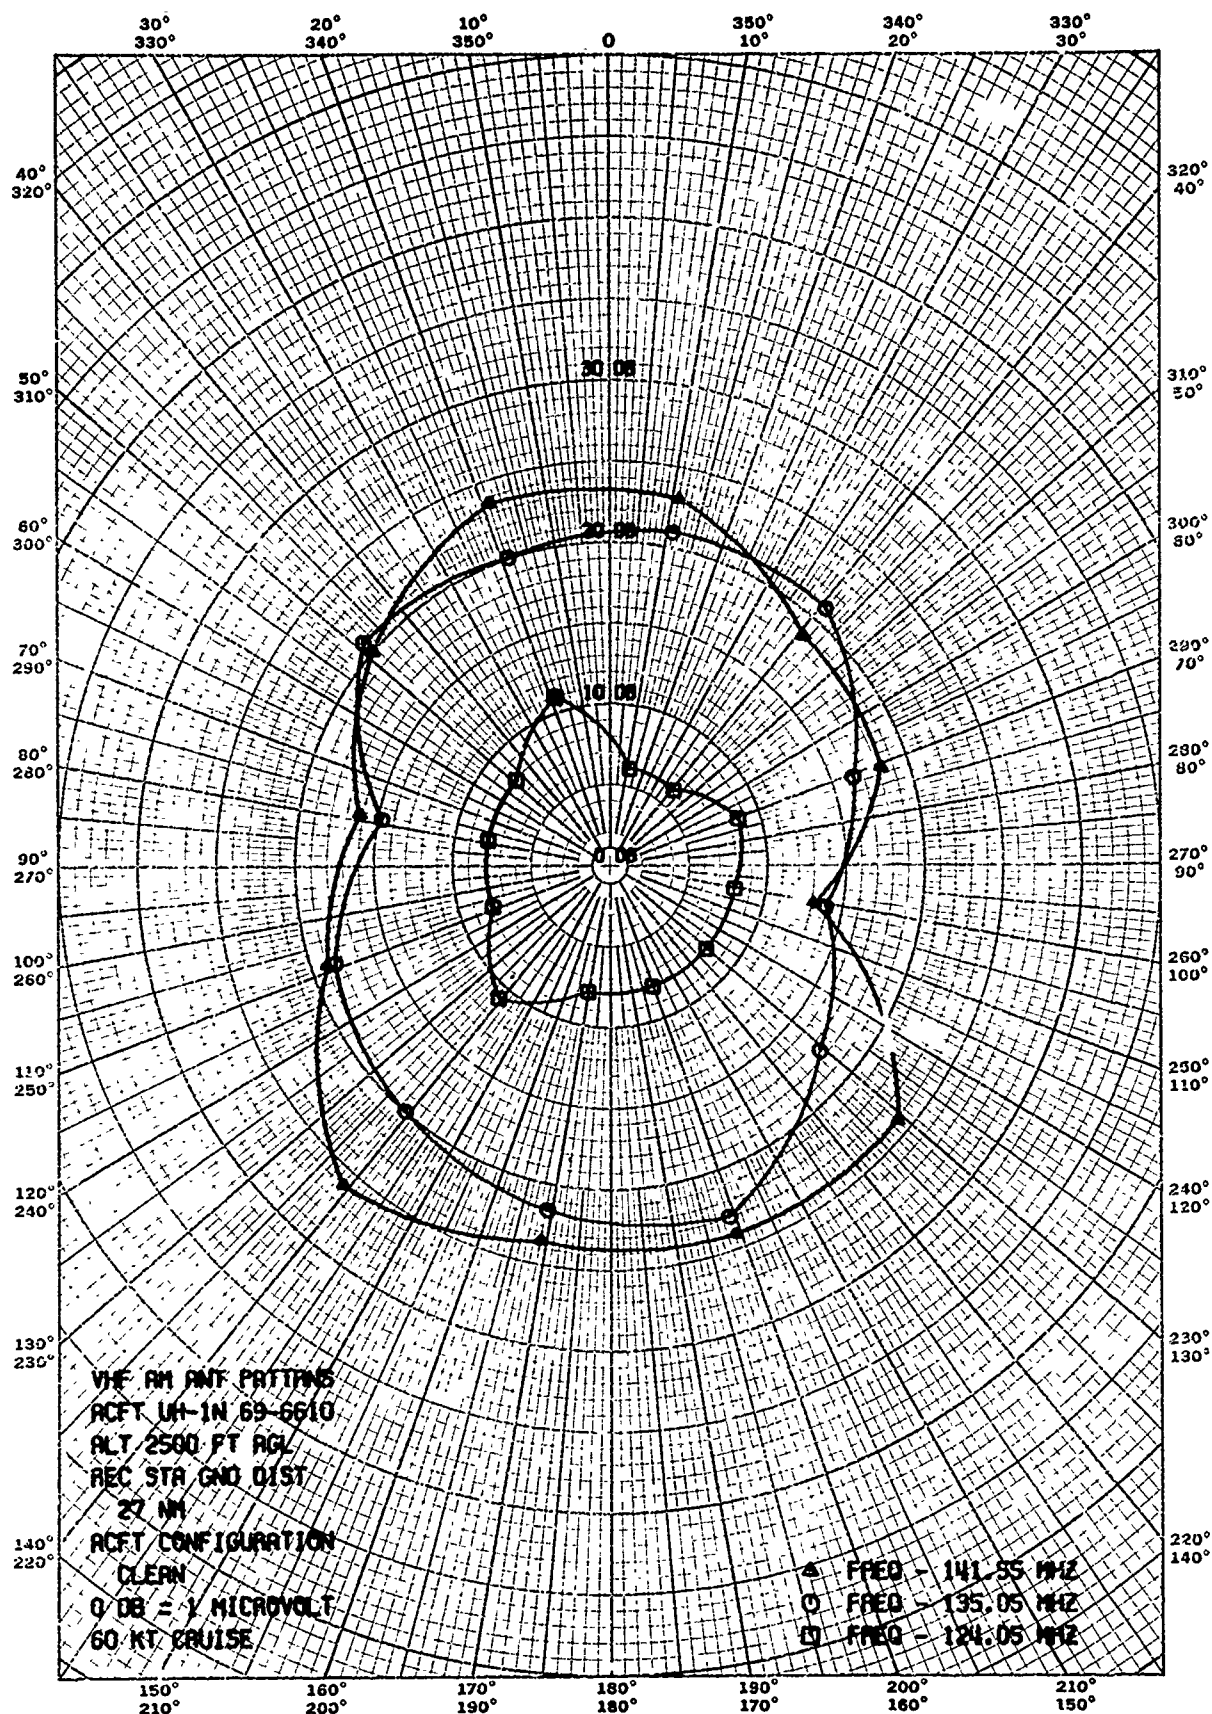
Figure 7 Post-ECP VHF-AM Antenna Patterns

Specification SCL-T-0045B required that no more than one half of the VHF-AM pattern nulls may be more than 6 decibels below the maximum signal strength. Figures 7 and 8 show the antenna radiation patterns obtained. It was noted that at the 2-NM distance the nulls were considerably less pronounced and coverage was excellent in all quadrants.
